INCODO Limited

Report Comparative Field Test of Electronic Search
Type Moisture Meters
Evaluation of thermal Imagers for Moisture
Detection

Date December 2006- January 2007 (Ver 3)

Prepared by P Probett

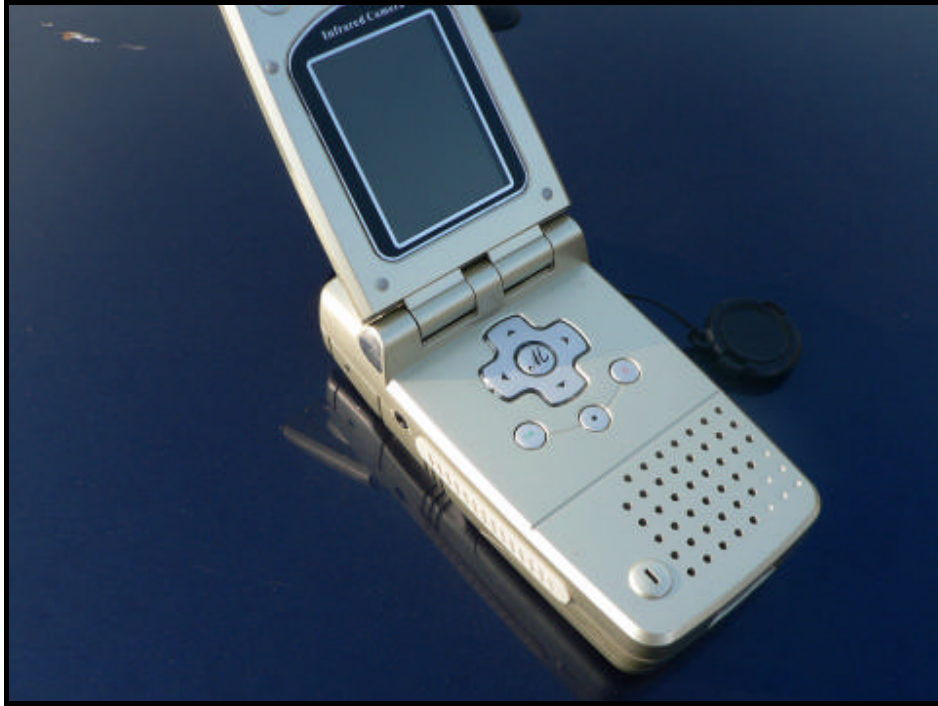
PIC 003 MOBIR thermal imaging camera

This is a very compact Chinese made clamshell unit having a thermal sensitivity of 0.12K, with many automatic features and records both a thermal image and companion digital daylight image.

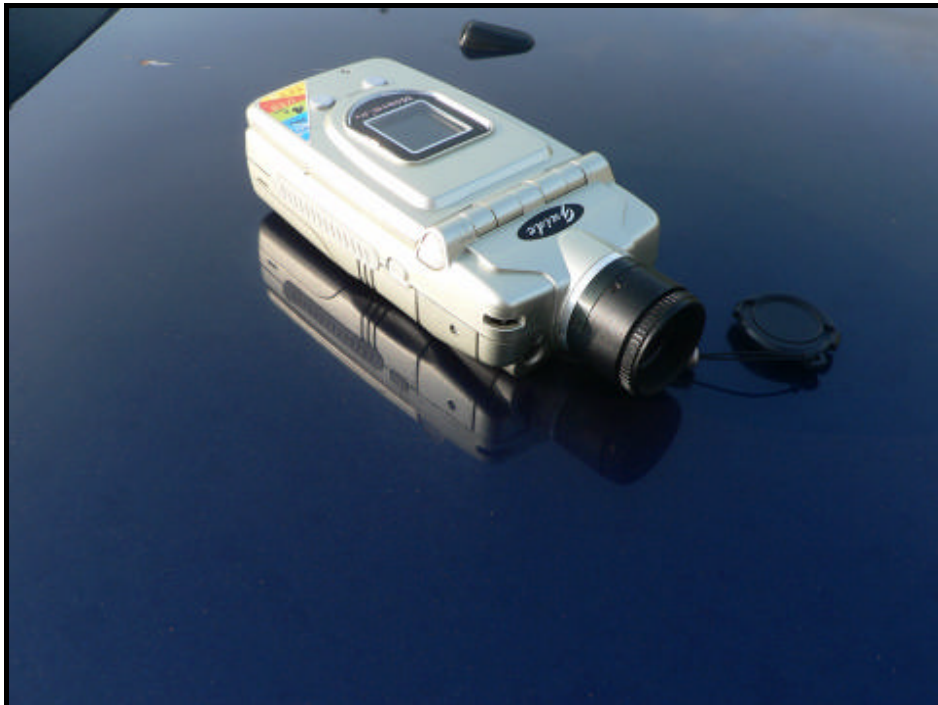
PIC 004 MOBIR thermal imaging camera

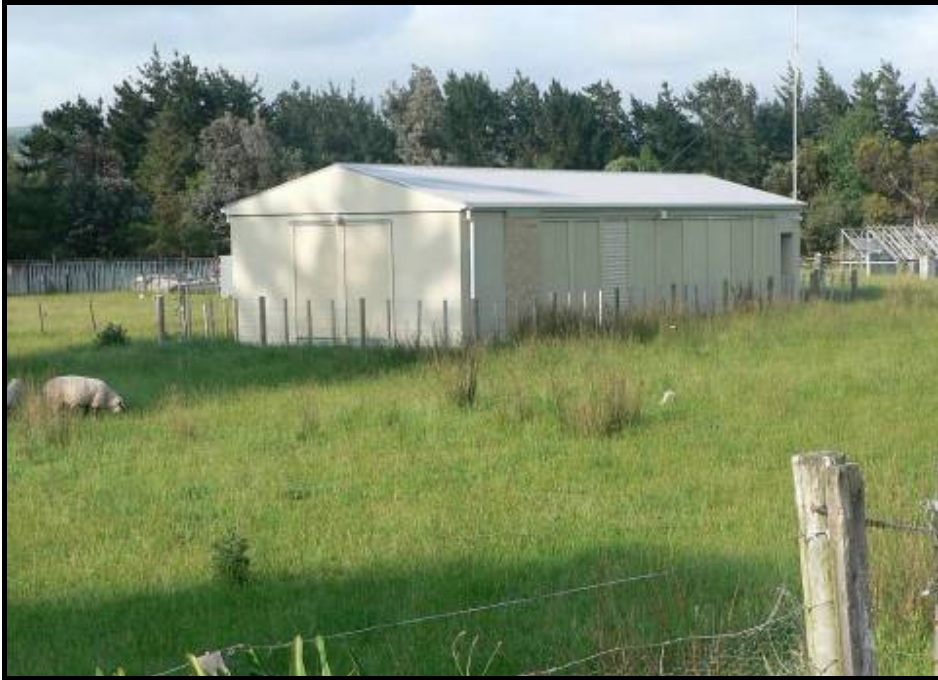
PIC 005 BRANZ test building, Judgeford

- 2.01 Contact was made with BRANZ and with their cooperation a test building clad with 2 examples each of 12 different but common cladding systems was made available.
This is the building Mark Bassett, principle scientist at BRANZ has been using to evaluate drying of wall systems. Mark injected a measured amount of water (10cc) into predetermined points in the timber framed wall approximately 6 days before the comparative testing was done.

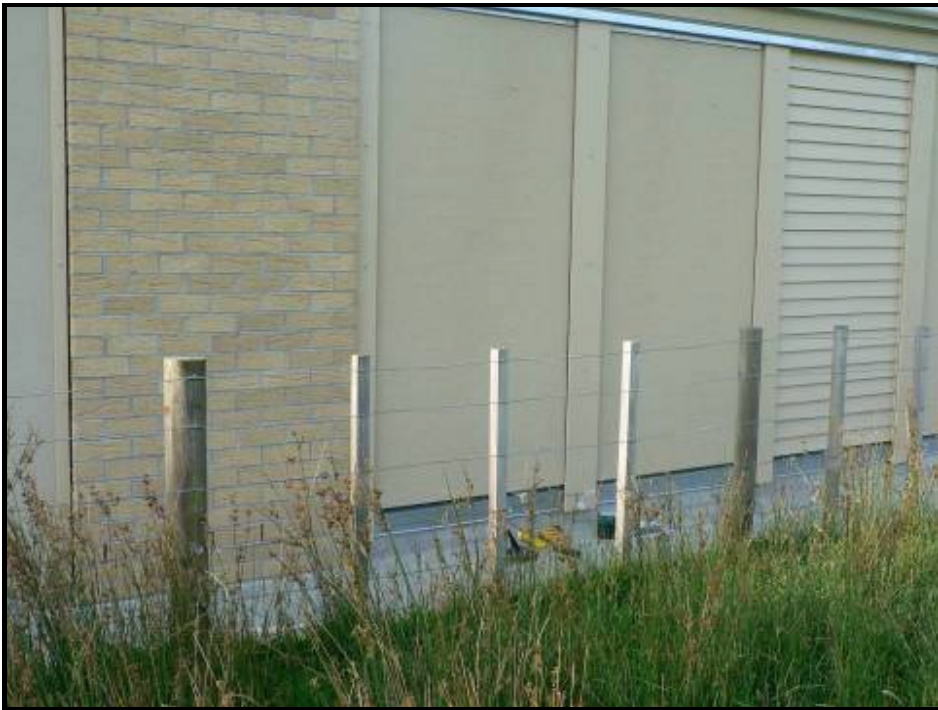
PIC 007 Close-up of typical test panels

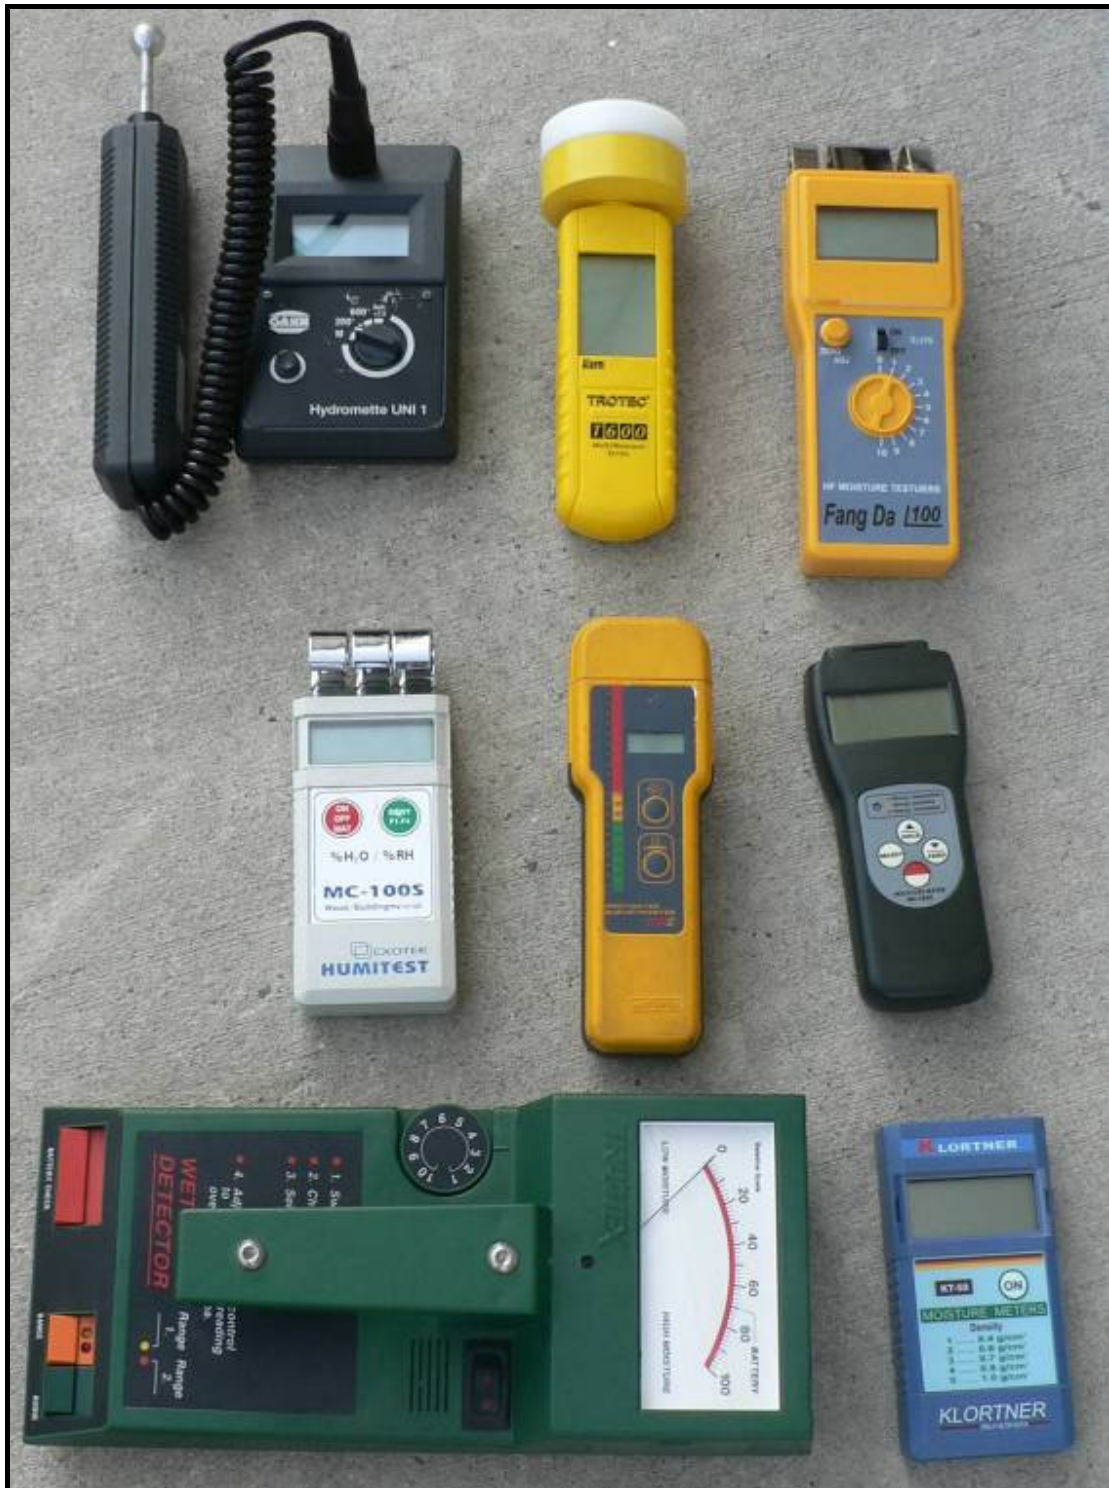
PIC 008 Meters top row from left Gann UNI 1, Trotec T600, Chinese clone of Humitest
 Level 2 Humitest 100s, Protimeter, Harbin MC785 PS
 Level 3 Tramex Wet wall, Kloritner KT 50
